## **06/02/83 Air Canada**

Report Number	NTSB/AAR-86/02
Access Number	PB86-910402
Report Title	Air Canada Flight 797, McDonnell Douglas DC-9-32, C-FTLU, Greater Cincinnati International Airport, Covington, Kentucky, June 2, 1983 (Supersedes NTSB/AAR-84/09)
Report Date	January 31, 1986
Organization Name	National Transportation Safety Board Bureau of Accident Investigation Washington, D.C. 20594
WUN	3751-G
Sponsor Name	NATIONAL TRANSPORTATION SAFETY BOARD Washington, D. C. 20594
Report Type	Aircraft Accident Report June 2, 1983
Distribution Status	This document is available to the public through the National Technical Information Service Springfield, Virginia 22161
Report Class	UNCLASSIFIED
Pg Class	UNCLASSIFIED
Pages	116
Keywords	Air carrier, DC-9, lavatory fire, electrical arcing, source of ignition, combustible materials, emergency descent, flashfire, evacuation procedures.
Abstract	<p>On June 2, 1983, Air Canada Flight 797, a McDonnell Douglas DC-9-32, of Canadian Registry C-FTLU, was a regularly scheduled international passenger flight from Dallas, Texas, to Montreal, Quebec, Canada, with an en route stop at Toronto, Ontario, Canada. The flight left Dallas with 5 crewmembers an

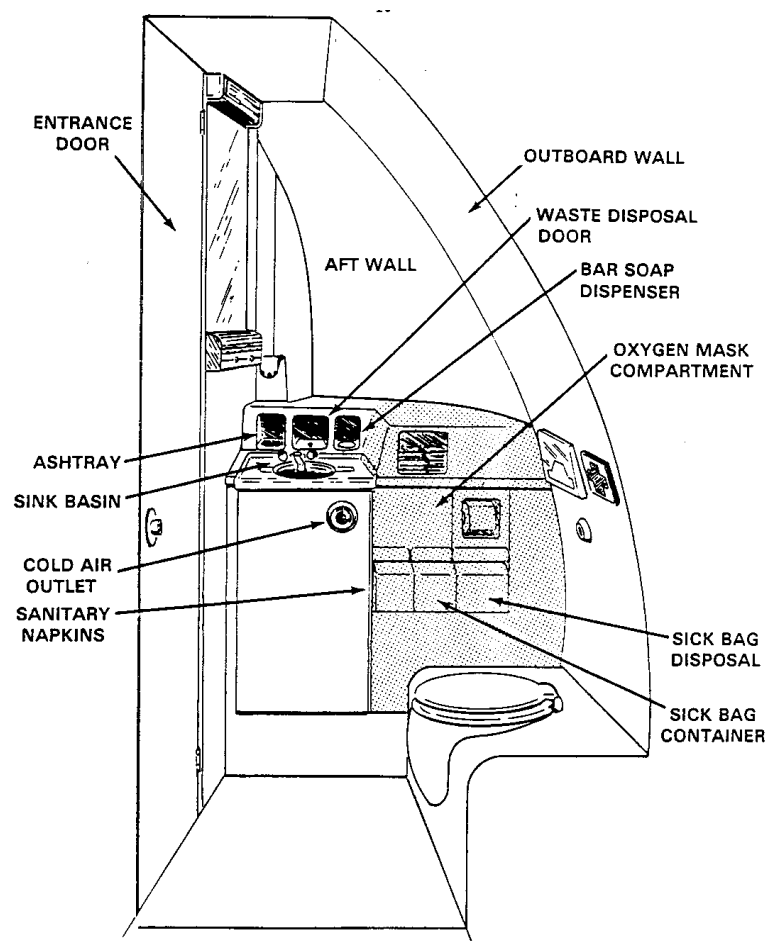
**Figure 9.--Diagram of aft lavatory, viewed aft.**

The aft lavatory was on the left side of the cabin, and began at FS 965 and extended aft to FS 1019, or just forward of the aft pressure bulkhead. The lavatory's outboard wall conformed essentially to the shape of the airplane's fuselage. There was a vanity section containing a stainless steel sink and amenities located along and extending forward from the aft wall. The commode containing a flushing motor was located along the lavatory's outboard wall. A trash chute and container were located below and behind the sink, and a fresh air supply outlet was positioned below the sink in the door of the vanity. Also, below the trash container, an aluminum shelf was installed. In addition, there was an oxygen outlet located in the oxygen mask compartment in the amenities section. (See [figure 9](#) and [figure 10](#).)

The aft lavatory was damaged extensively by fire and heat. Most of the lavatory's interior walls had been burned away. The entry door, which had been kept closed, was destroyed except within 16 inches of the floor. The aft pressure bulkhead and fuselage skin which comprised the outermost portion of the lavatory enclosure were intact, but were buckled and discolored to dark brown.

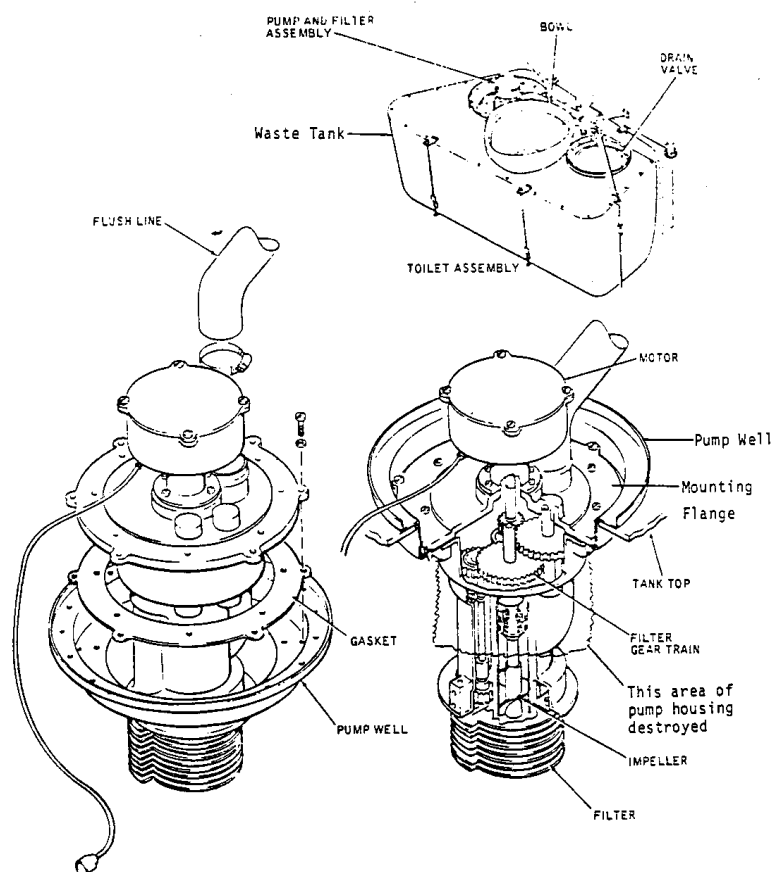
**Figure 11.—Lavatory pump and filter system.**

The flush motor was found attached to its mounting flange which was attached to the pump well. The flush motor assembly was found in approximately its normal position in the waste tank next to, but detached from, the flush pump and filter assembly. The motor housing was completely melted. Large concentrations of molten metal were found on the forward side of the mounting flange facing the toilet bowl, and on the aft side where the 3-phase electrical leads enter the motor housing. A portion of the wiring harness which supplies a.c. power to the flush timer, flush motor, and flush button was encased in the molten metal on the aft side of the motor. The rotor section of the flush motor was encased in molten metal above the field windings; however, the rotor did not appear to have been damaged extensively by heat. [\(See figure 11\).](#)

The flush pump and filter assembly found in the waste tank was partially intact. The filter and pump mechanisms, which apparently had been located below the water line in the waste tank, were in good condition. Above the water line, the plastic housing for the pump and filter was melted away. This housing also encloses the filter gear train and is part of the assembly used to mount the pump and filter to the pump well. The exposed shaft and gears showed heat damage. The gears, which make up the filter gear train that connects the motor to the pump and filter, were found lying in the waste tank. The plastic mounting ring, which mates the pump and filter housing to the pump well, was found intact among the debris in the waste tank. There was some slight melting of the top surface of the mounting ring. All of the components of the flush motor and pump assembly were removed for further examination.

When the flush motor and its associated mounting were removed from the toilet tank, two wires in the motor harness and all of the wires in the power harness broke just aft of the motor housing due to brittleness. To facilitate removal of the flush motor assembly, the remaining wires of the motor harness were cut a few inches aft of the motor housing and tagged for identification.

by heat. The flush motor involved in the accident did not show any evidence of internal heat damage or internal failure.

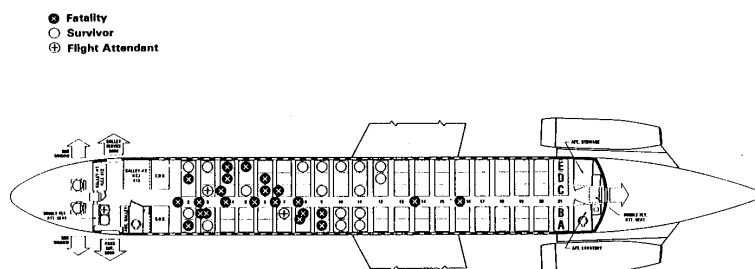
**Figure 12.—Diagram of passenger seat locations.**

During descent, the cabin filled with black, acrid smoke from the ceiling down to about knee level. Passenger and flight attendant testimony and statements indicated that all of the surviving passengers had covered their faces with either wet towels distributed by the flight attendants or articles of clothing. They all attempted to breath as shallowly as possible, and all reported that the smoke hurt their noses, throats, and chests and caused their eyes to water. By the time the airplane landed, they could not see their hands in front of their faces while seated or standing. Some of the passengers said that they leaned forward in their seats and put their heads down and that this seemed to relieve some of the distress they were experiencing. One passenger was experiencing severe distress trying to breathe. He was brought forward and seated on the forward flight attendant jump seat, and the flight attendant in charge administered oxygen to him from the portable bottle.
